September 2009 Newsletter

Stabilization and Tourism at the Gambia River's Atlantic Trade Sites: the James Island Conservation and Survey Project

Abstract

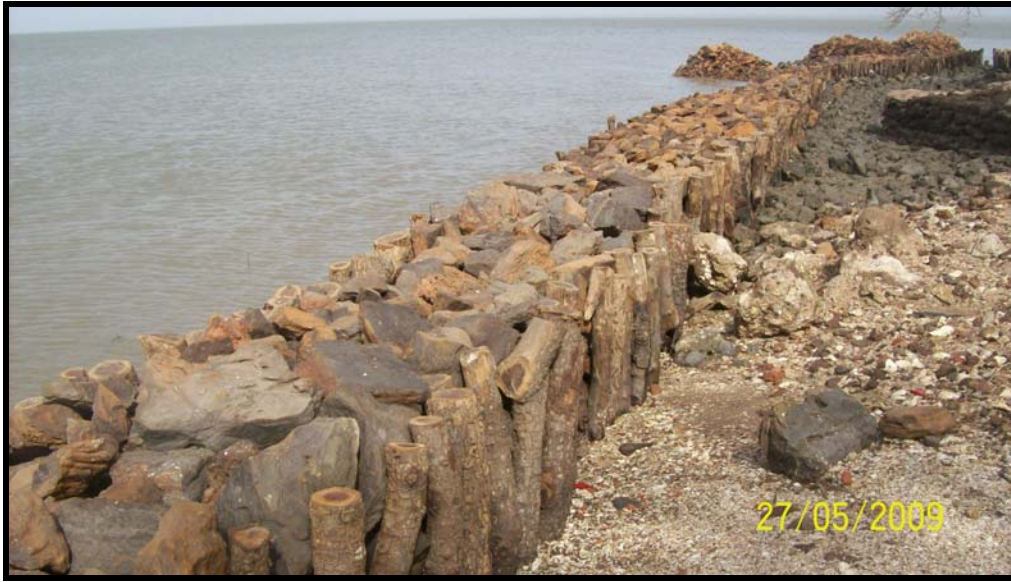
Figure 3. The James Island sea wall (photograph by Mr. Baba Ceesey, NCAC).

The cistern, northwest bastion, and northeast bastion are subject to continuous destabilization at high tide. In order to combat this, the NCAC has erected a sea wall to block the tide from reaching the fort, and has undertaken to rebuild or stabilize the interior sections of the fort that have collapsed or are at risk for further damage during the rainy season.

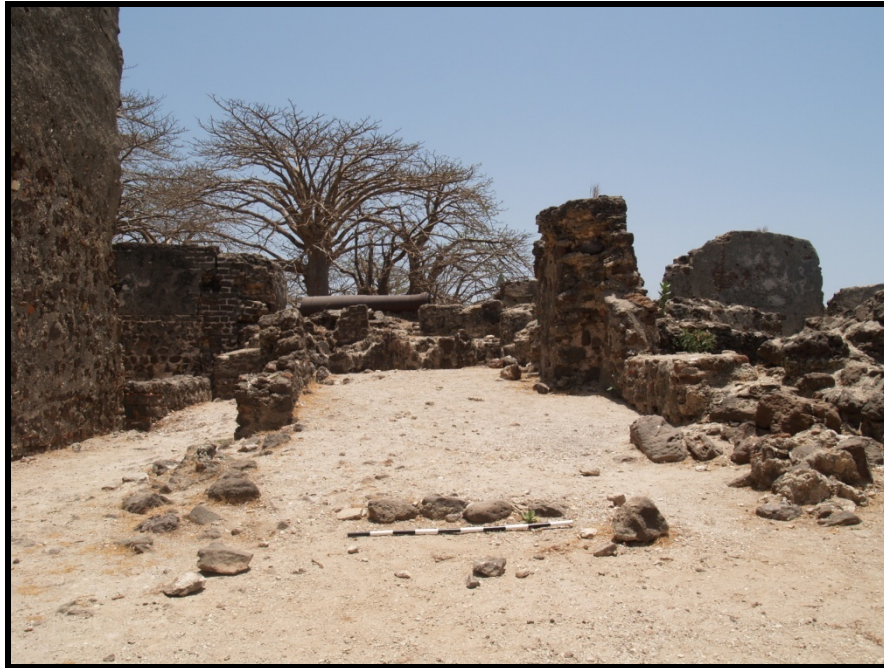
unidentified room that was next to the former tower and southwest bastion that possibly served as a store. Finally, a section of the fort that contained the upper apartments between the northwest and northeast bastion abutting the cistern and the magazine, are present, and are in relatively good condition (Figure 6). While portions of the second floor wall above the governor's room in the northern section of the fort are complete, none of the floors associated

Figure 6. North upper apartments between northwest and northeast bastions, view from the east (photograph by author).

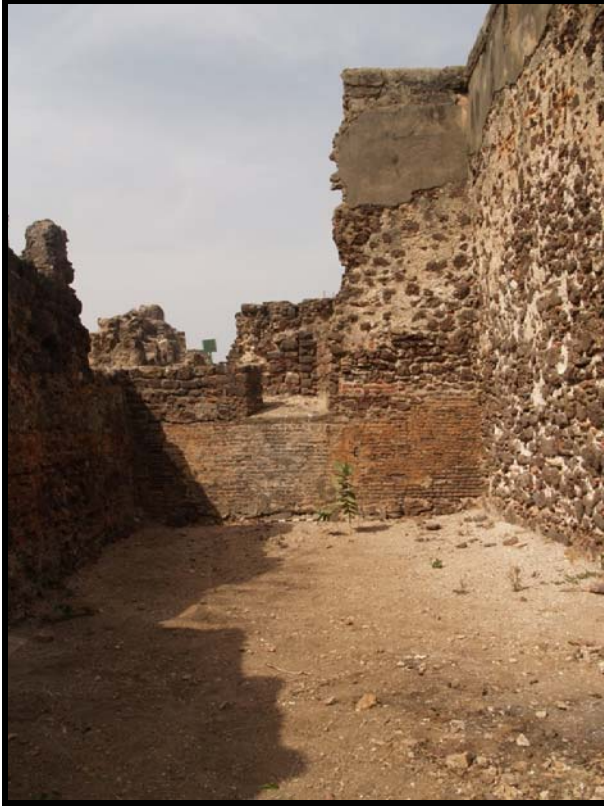
The lower level rooms, and in particular the internal separations, are more intact than those on the upper level. A single wall creating a passage area between the long room and council room was added sometime after 1755, though the exact date of construction is not known (see Figure 7 and 4). In addition to apartments, five other spaces have been identified, including the former governor's room, council room, long room, courtyard, and lower floor of the tower. The governor's room, council room, and long room were identified by the NCAC in 1997 and contain plywood signs identifying them as such to visitors (Figure 8). The courtyard and the tower area are not currently marked for tourists. As seen in many of these images, features of the fort construction are apparent in several walls which indicate shifts in material (i.e., stone and brick), wall repairs, and additions to the fort over time as seen in Figure 7. Unfortunately, repairs made to the ruins after its abandonment including the reconstruction or addition of stairs, are not always distinguishable from historic period construction phases.

Figure 7. Lower level western apartments showing the absence of internal wall taken from the south (photograph by author).

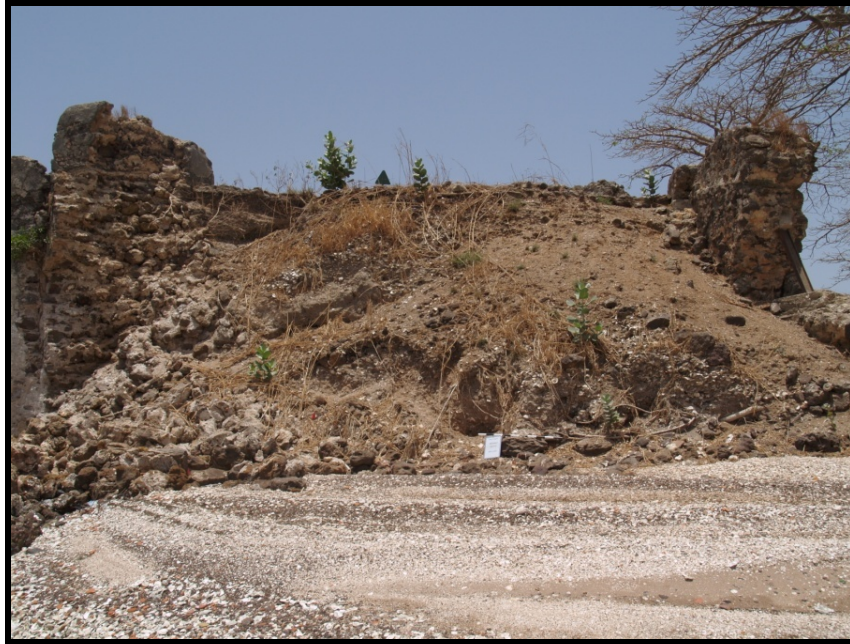
Figure 10. Collapsed north wall of the northwest bastion (photograph by author).

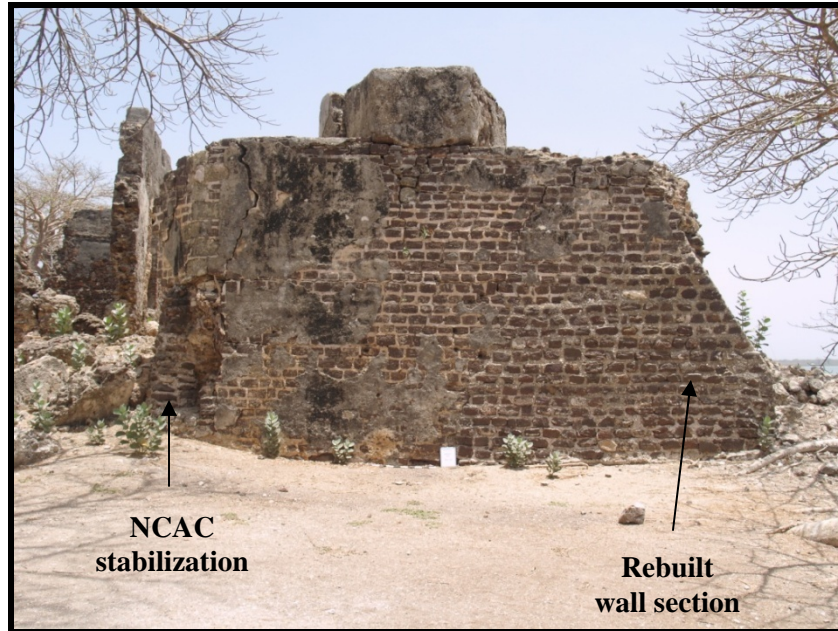
The northeast bastion has the only interior room (the magazine) out of the four bastions (Figure 11-12). It has also suffered the most damage from erosion and vegetation. A baobab tree has destabilized the bastion's base along the river, and few exterior walls remain. As part of this project under the NCAC, the tree has been anchored, though not removed in order to prevent further collapse. As a result, the northeast bastion has received the greatest attention from the NCAC in terms of stabilization and restoration (see Figure 12). A large portion of the eastern wall has been rebuilt. Finally, although parts of the original stairs remain, in the collapsed portion of the south side of the bastion, a larger stair was added by the NCAC in the 1990s (see Figure 11).

Figure 11. East wall of southeast bastion showing NCAC rehabilitation efforts (photograph by author).

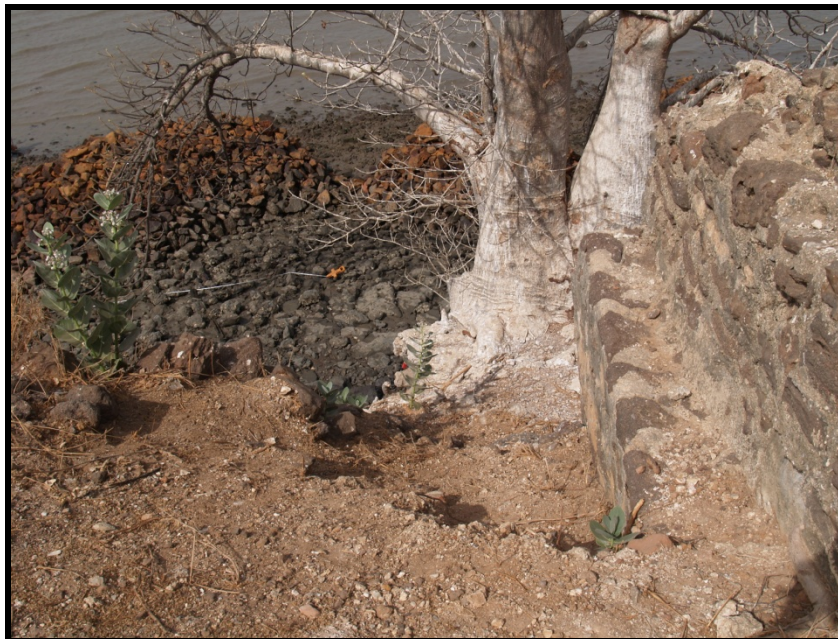
Figure 12. North wall of southeast bastion showing significant collapse and baobab tree growing at the base (photograph by author).

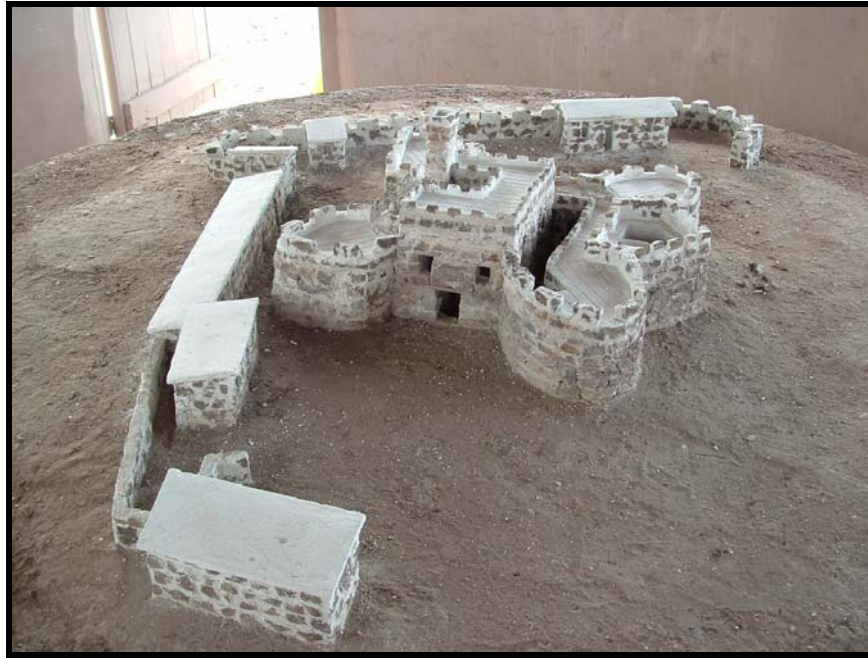
These six panels, in addition to model of the fort based on the 1755 map, will serve as self-guided tour markers (Figure 15). A single introductory panel will provide a brief description of the island's history and a timeline for the fort's occupation, reconstruction, and abandonment based on historical information I gathered from the British and Gambian National Archives between 2004 and 2008. The remaining five panels will be scattered throughout the fort and the island providing in-depth descriptions of the different rooms and out structures, in addition to company employees, daily life on the island, and the location's role in the trans-Atlantic slave trade.

Figure 15. Model of James Island based on the 1755 survey map (photograph by Mr. Baba Ceesey, NCAC).
